**Advantage Home Inspections**

**Advantage Home Inspections  
Confidential Inspection Report**

[REDACTED]  
**Newburgh, NY 12550**

March 29, 2012

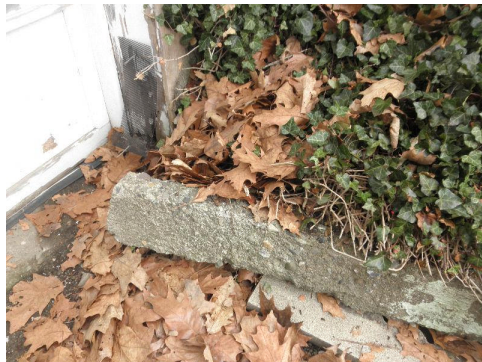
The retaining wall is made of concrete. Partially collapsed.

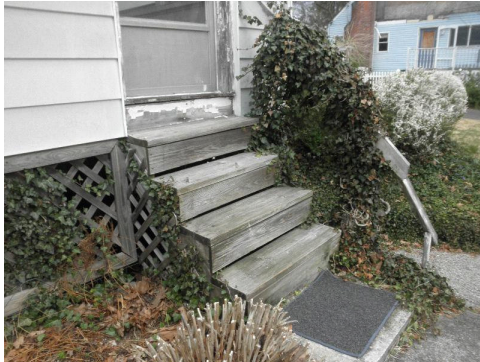
**Action Recommended** - The steps need some repair or replacement. **Action Recommended** - One or both of the hand rails are damaged. Repair is recommended.

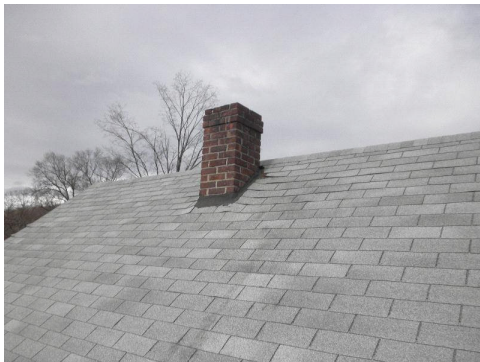
**Action Recommended** - The chimney does not meet the required height. The chimney should extend 3 feet above the roof through which it protrudes or be 2 feet above any surface within 10 feet horizontally, whichever is higher.

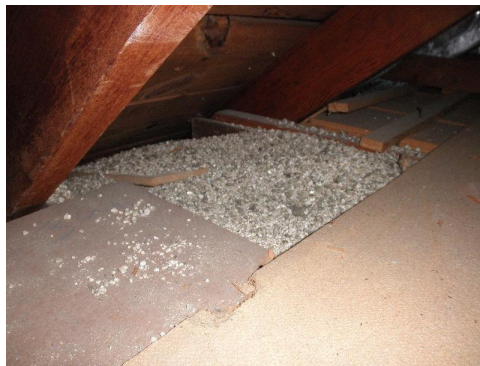
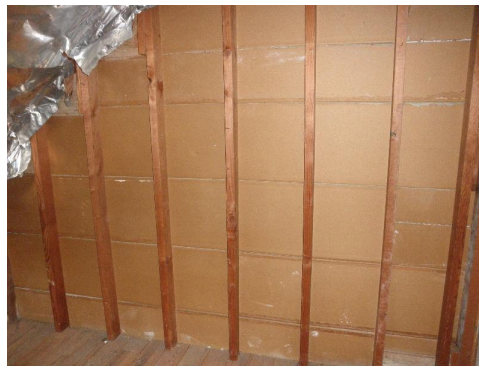
**Action Recommended** - The some of the insulation in the attic contains vermiculite. Certain brands of vermiculite, manufactured prior to 1990, may contain asbestos fibers. The date the vermiculite was installed is unknown. Advantage Home Inspections does not perform tests for asbestos.

**Action Recommended** - There is very little insulation in the attic. Installation will reduce energy costs

Further testing of the vermiculite for presence of asbestos should be performed by a qualified lab.

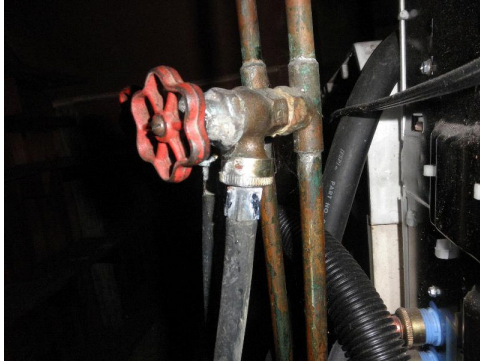
**Action Recommended-** The following water valve for the washer is leaking. Repair is recommended. Cold water valve.

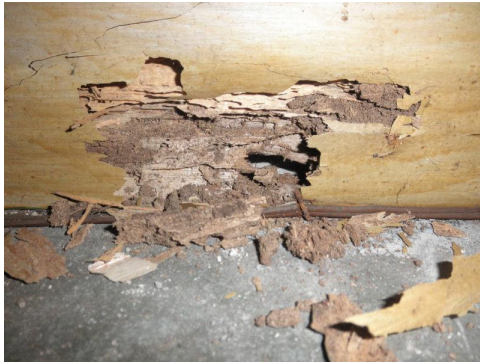
**Action Recommended-** There is a condition in the wall sheeting that needs to be repaired. There is evidence of leakage in at least one wall. The stain appears to be from a current leakage. Front wall.

**Action Recommended** - Evidence of termites and termite damage.

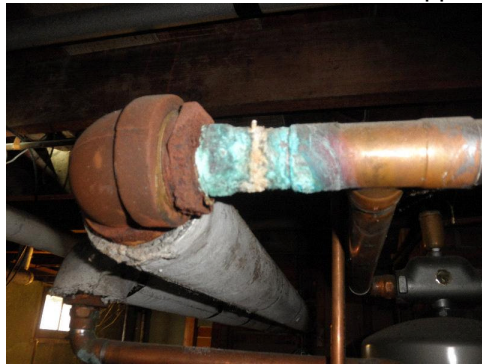
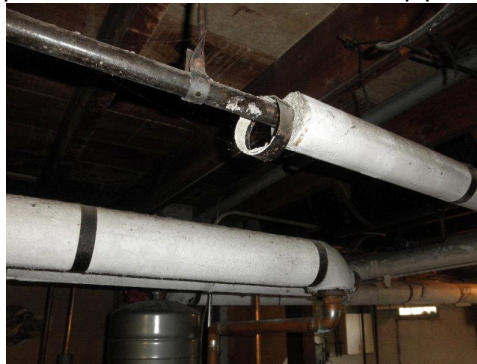
The heat pipes are covered with an insulation which may contain asbestos. Asbestos can only be confirmed by a qualified lab. Advantage Home Inspections does not perform tests for asbestos.

**Attention Recommended** - The copper pipes as it connects to the cast iron pipe has signs of deterioration.

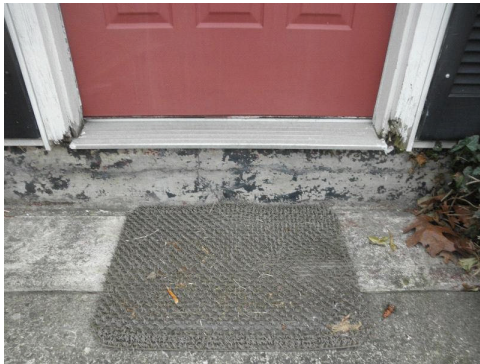
The noted door(s) is located Front, The exterior door in the noted location(s) is: Steel, **Attention Recommended** - The wood frame around the exterior door has water damage at the bottom.

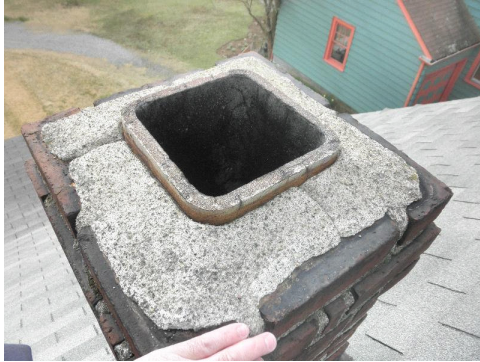
**Attention Recommended** - The chimney drip cap is made of mortar. Its function is to keep water from entering between the masonry stack and brick, causing deterioration. This cap needs some repair so that it can function as intended.

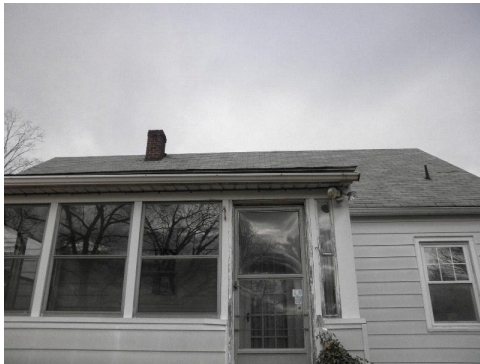
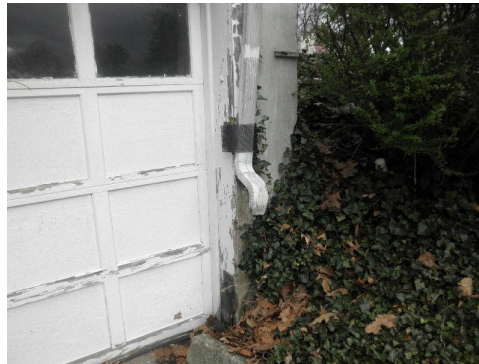
**Attention Recommended** - The gutter system on the roof edge appears to be inadequately sloped to carry the water to the downspouts. Porch gutter Run-off water needs to flow away from the side of the house at least 6 feet. This will allow the run-off to get far enough away to not interfere with the foundation. The downspout by the garage door should be redirected away from this area

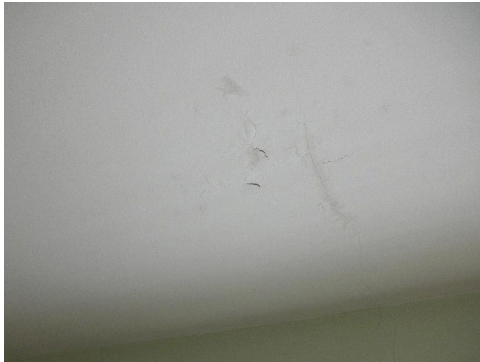
**Attention Recommended** - There is a condition in the ceiling of the noted room that needs to have attention. There is evidence of an unrepaired stain on the wall caused by a prior moisture leak. **Front left bedroom.**

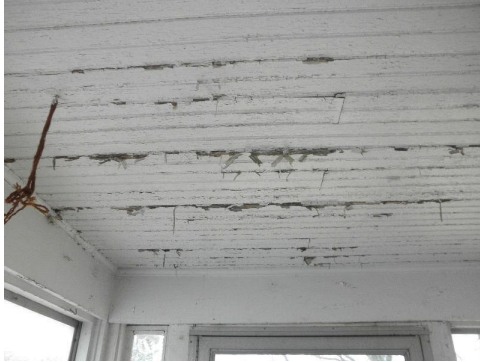
**Attention Recommended** - There is a condition in the ceiling of the noted room that needs to have attention. Peeling paint.

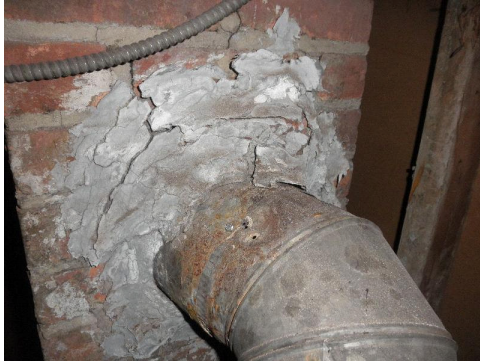
The flue pipe is metal **Attention Recommended-** The furnace/boiler flue as installed appears to need some attention. The boiler stack should be properly sealed to the chimney.

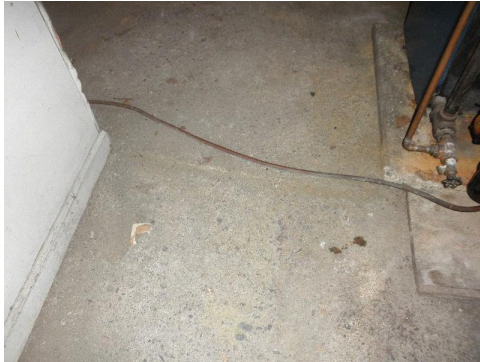
**Attention Recommended** - The fuel line runs across a pathway in the basement. Damage can occur to the line. Protection or redirecting the fuel line is recommended.

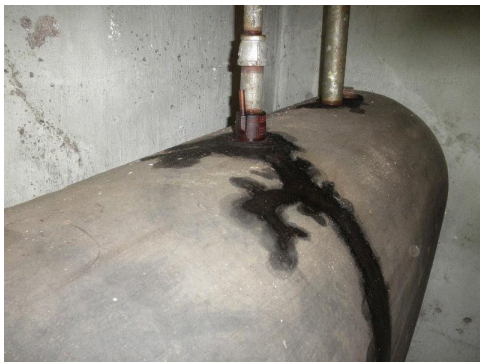
The diameter of the vent pipe is smaller than the fill pipe. This can cause blow back through the tank joints. Replacement is recommended.

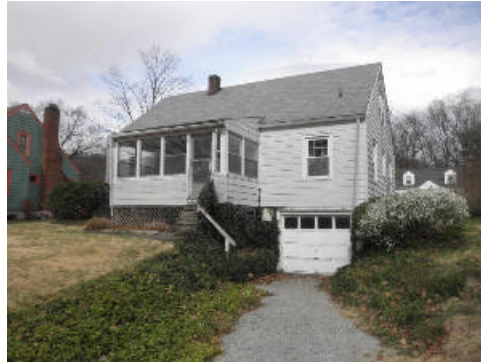
**Attention Needed** - The rear driveway is pitched towards the garage. There is no drain at the base to pick up run off water.

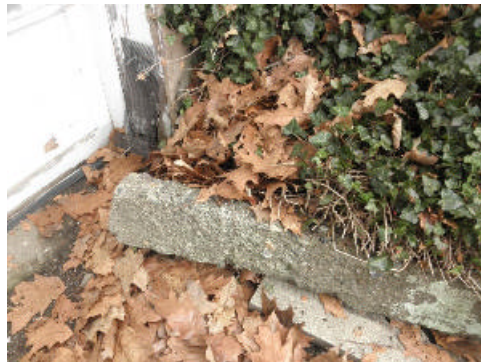
Next to rear driveway.

The retaining wall is made of concrete. Partially collapsed.

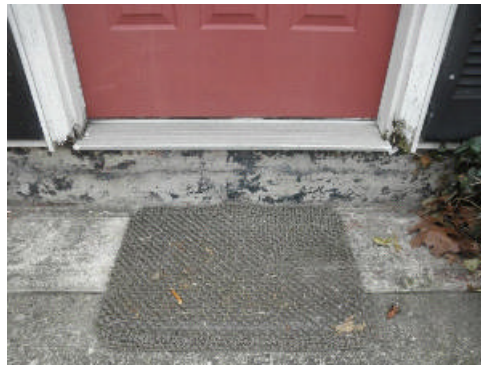
The noted door(s) is located Front, The exterior door in the noted location(s) is: Steel, **Attention Recommended** - The wood frame around the exterior door has water damage at the bottom.

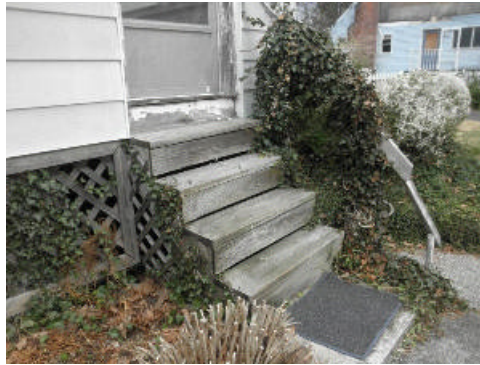
**Action Recommended** - The steps need some repair or replacement. **Action Recommended** - One or both of the hand rails are damaged. Repair is recommended.

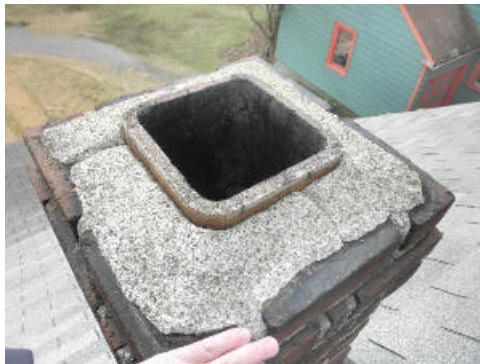
**Attention Recommended** - The chimney drip cap is made of mortar. Its function is to keep water from entering between the masonry stack and brick, causing deterioration. This cap needs some repair so that it can function as intended.

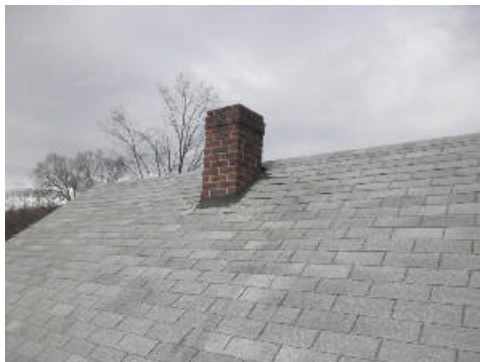
**Action Recommended** - The chimney does not meet the required height. The chimney should extend 3 feet above the roof through which it protrudes or be 2 feet above any surface within 10 feet horizontally, whichever is higher.

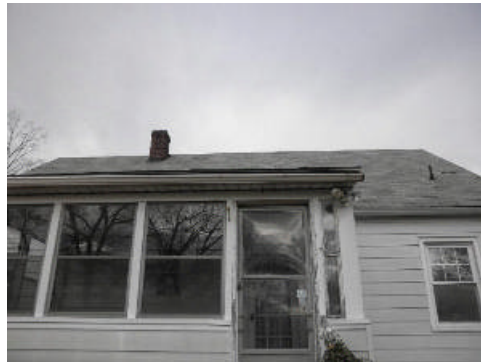
**Attention Recommended** - The gutter system on the roof edge appears to be inadequately sloped to carry the water to the downspouts. Porch gutter Run-off water needs to flow away from the side of the house at least 6 feet. This will allow the run-off to get far enough away to not interfere with the foundation.

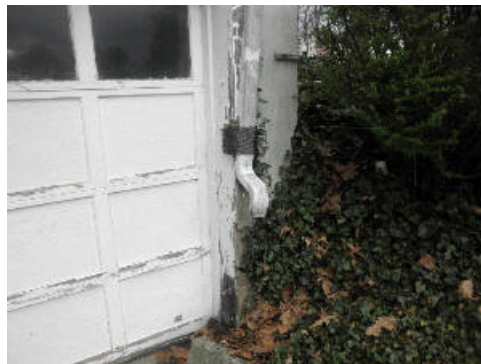
The downspout by the garage door should be redirected away from this area

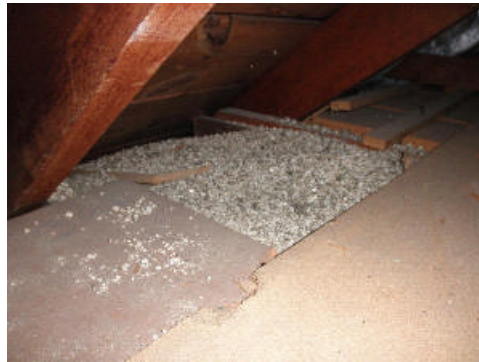
**Action Recommended** - The some of the insulation in the attic contains vermiculite. Certain brands of vermiculite, manufactured prior to 1990, may contain asbestos fibers. The date the vermiculite was installed is unknown. Advantage Home Inspections does not perform tests for asbestos.

Further testing of the vermiculite for presence of asbestos should be performed by a qualified lab.

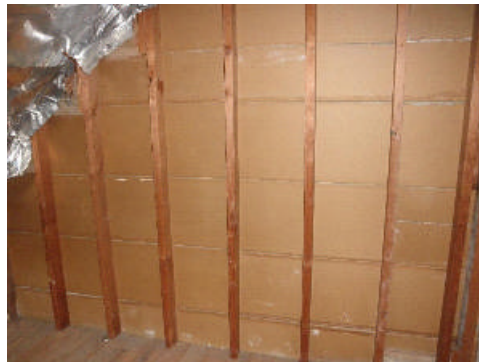
**Action Recommended** - There is very little insulation in the attic. Installation will reduce energy costs

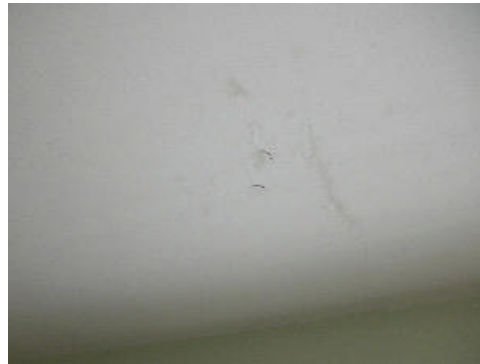
**Attention Recommended** - There is a condition in the ceiling of the noted room that needs to have attention. There is evidence of an unrepaired stain on the wall caused by a prior moisture leak. **Front left bedroom.**

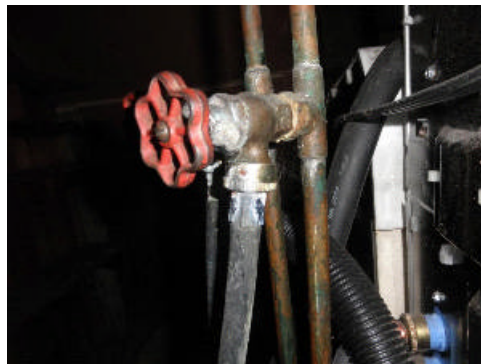
**Action Recommended-** The following water valve for the washer is leaking. Repair is recommended. Cold water valve.

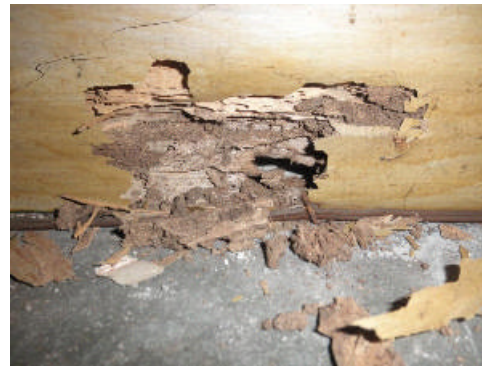
**Action Recommended-** There is a condition in the wall sheetrock that needs to be repaired. There is evidence of leakage in at least one wall. The stain appears to be from a current leakage. Front wall.

**Action Recommended -** Evidence of termites and termite damage.

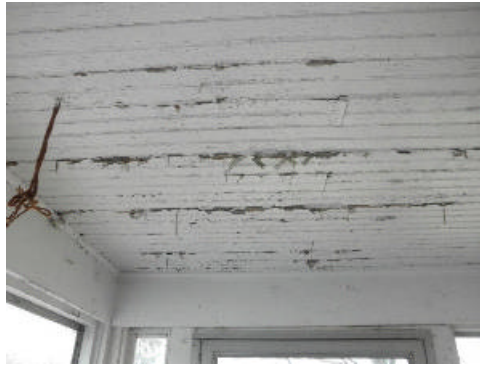
**Attention Recommended** - There is a condition in the ceiling of the noted room that needs to have attention. Peeling paint.

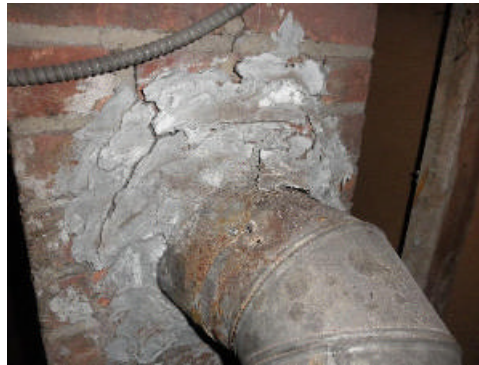
The flue pipe is metal **Attention Recommended-** The furnace/boiler flue as installed appears to need some attention. The boiler stack should be properly sealed to the chimney.

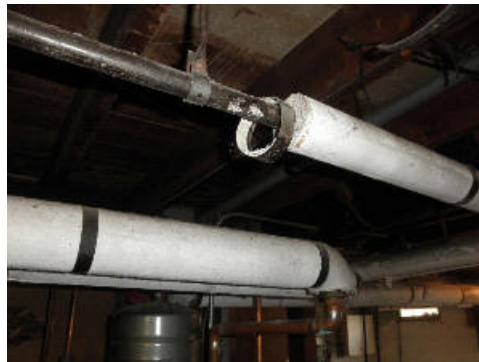
The heat pipes are covered with an insulation which may contain asbestos. Asbestos can only be confirmed by a qualified lab. Advantage Home Inspections does not perform tests for asbestos. **Attention Recommended** - The copper pipes as it connects to the cast iron pipe has signs of deterioration.

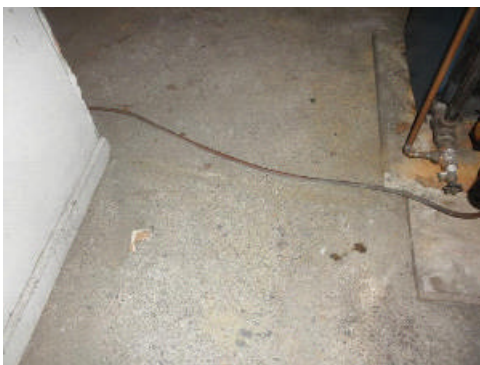
**Attention Recommended** - The fuel line runs across a pathway in the basement. Damage can occur to the line. Protection or redirecting the fuel line is recommended.

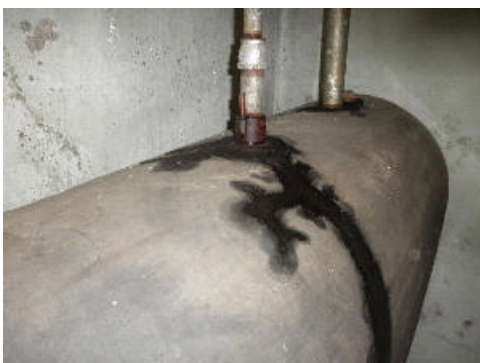
The diameter of the vent pipe is smaller than the fill pipe. This can cause blow back through the tank joints. Replacement is recommended.
