On approximately, November 15, 2003, the Texas Department of Transportation located in the Amarillo District, experienced a vehicle hit.

The sign structure impacted was a single tri-base guide sign. This sign utilized the Dent Breakaway Bolts and both posts broke away with no additional ground anchor or post damage and was reinstalled by our Sign Crew.

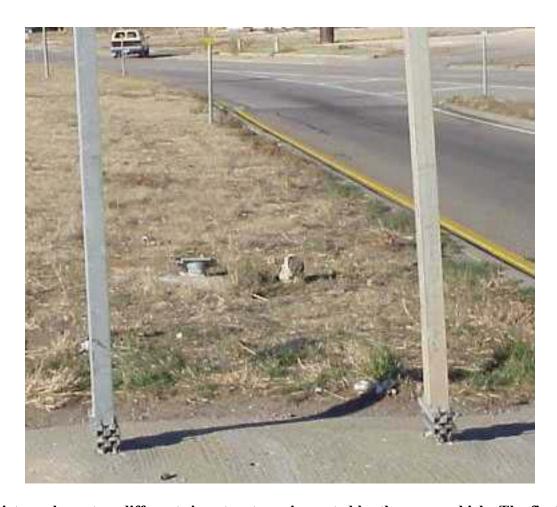
This picture shows two different sign structures impacted by the same vehicle. The first of the two as shown is installed on two, W-4, I Beams and this structure broke away as designed allowing the sign crew to just change the bolts and reinstall the sign structure. The second sign structure located directly behind the two-post structure was installed on the Texas tri-base system using the ring. In this case, the ground anchor was bent over and the concrete foundation busted apart upon impact requiring replacement. The Dent Bolts were not utilized on the tri-base system.

Using the Dent Breakaway Bolts on the sign structure saved the state money and labor costs and required no time loss waiting for structure and base fabrication.
